Eco-restoration of IDL Lake, Kukatpally, Hyderabad

Situational Analysis & Feasibility Study

SaciWATERS
SOUTH ASIA CONSORTIUM FOR
INTERDISCIPLINARY WATER RESOURCES STUDIES

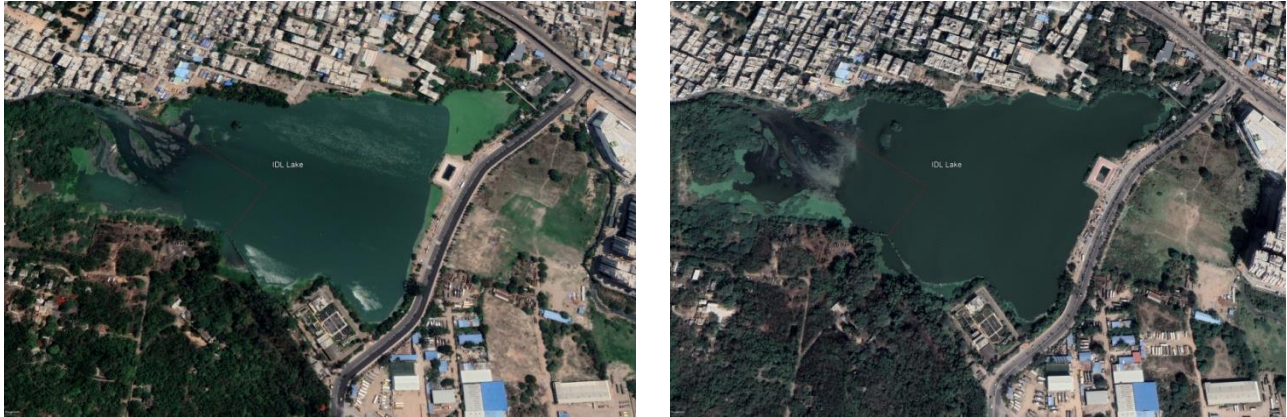
Fig 4b and b: Negligible change in water spread area during May 2021 and December 2021

This seasonal change in water spread area wasn't noticed any year after 2005-06. Currently, not only the lake area but the bordering land of GOCL is also submerged under water throughout the year (Fig 4a and 4b).

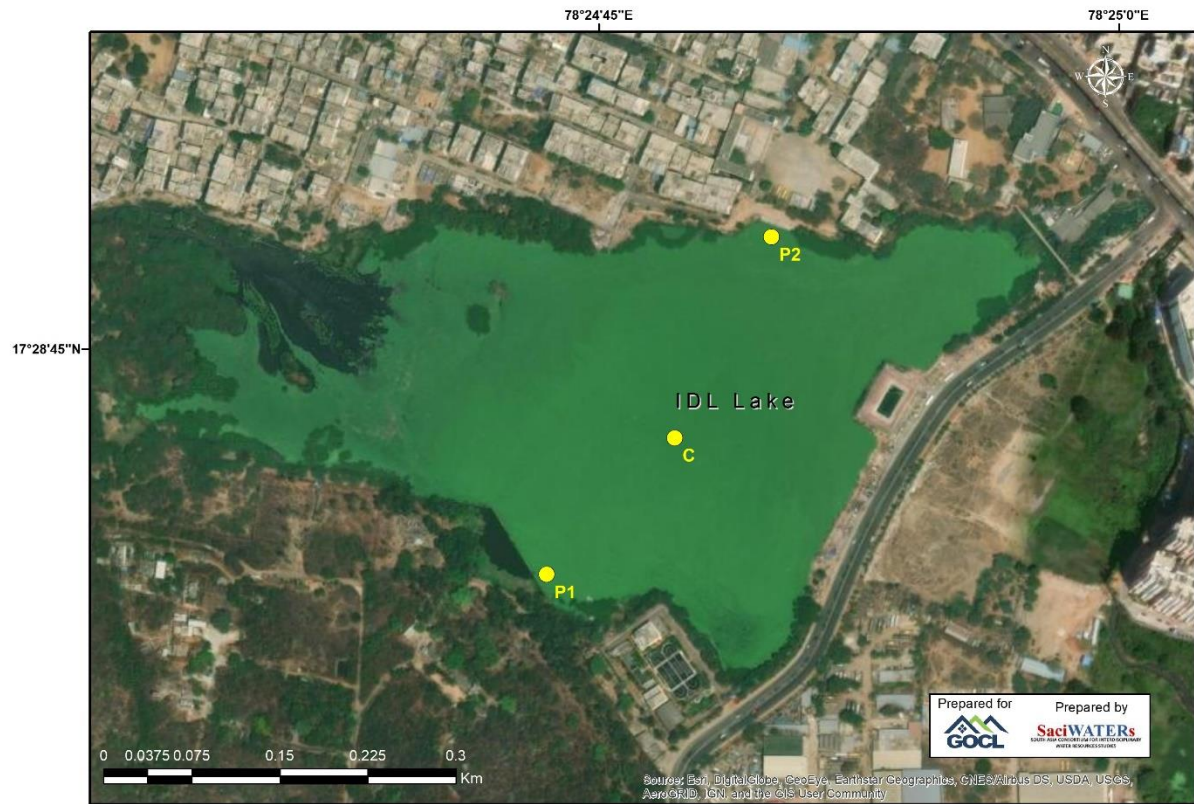
Map.2: Sampling Stations

Water samples for determining physico-chemical parameters to be carried out in the field were collected in clean five (5) liters capacity plastic containers. The surface sediment samples were collected using long-handled stainless-steel scoop in clean polyethylene zip-lock bags. The collected water and sediment samples were immediately transported to EPTRI, Hyderabad for analysis. Macrophytes were also identified during the field visit.

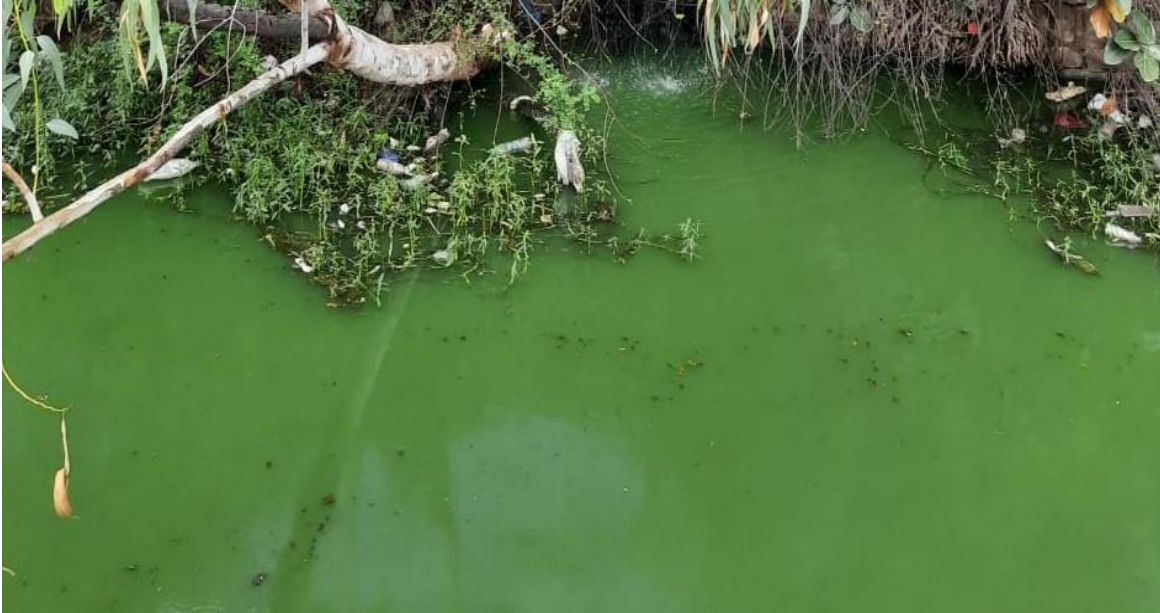
Pic: Toxic algal blooms in the lake near the bridge

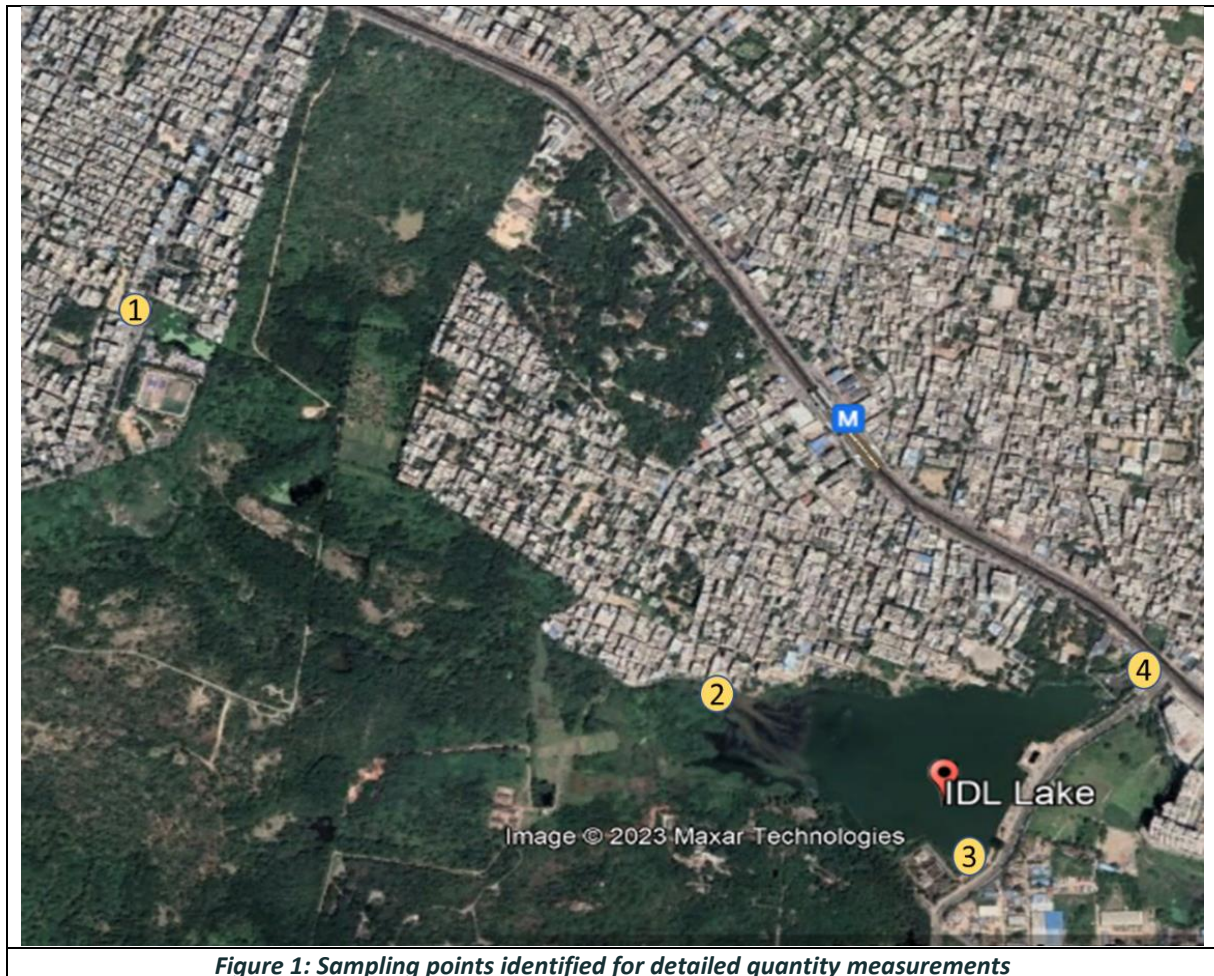
Figure 1: Sampling points identified for detailed quantity measurements

For the measurements to be undertaken, the points for quantity assessment were first decided based on a reconnaissance visit undertaken on the 3rd of January with the GOCL team. The points selected for measurement were those sections, which allowed the team to ascertain the channel discharging the total flow into the lake. These sections were the portions where the flow from all prior channels would culminate into. These points are shown in Figure 1 below (The figure here indicates the location of the quantity (flow) sampling points in satellite image).

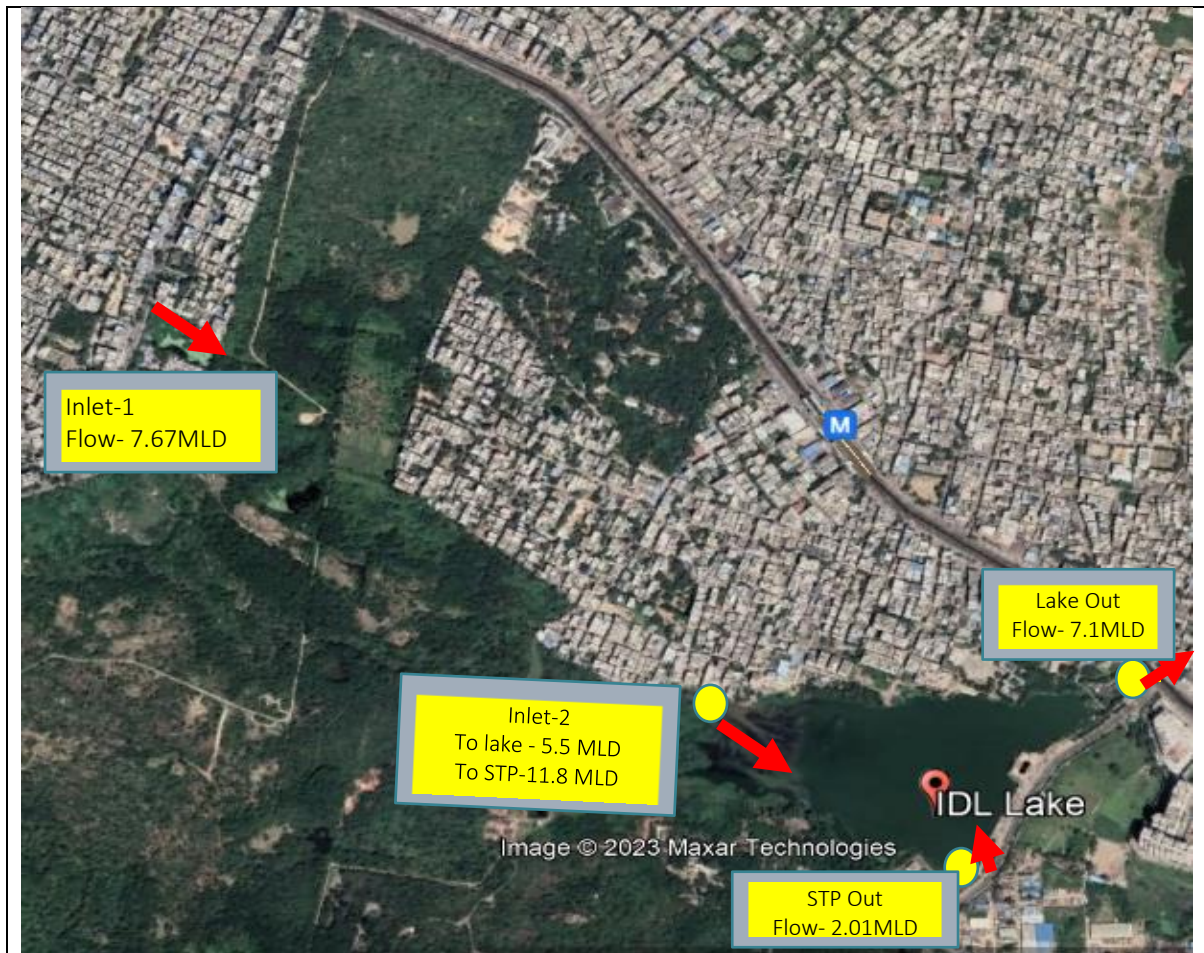
Figure 11: Flow data measured at all the inlets and outlet

Note: Detailed flow measurements at every location and each cross-section of the channels are presented in Annexure 1 for reference.

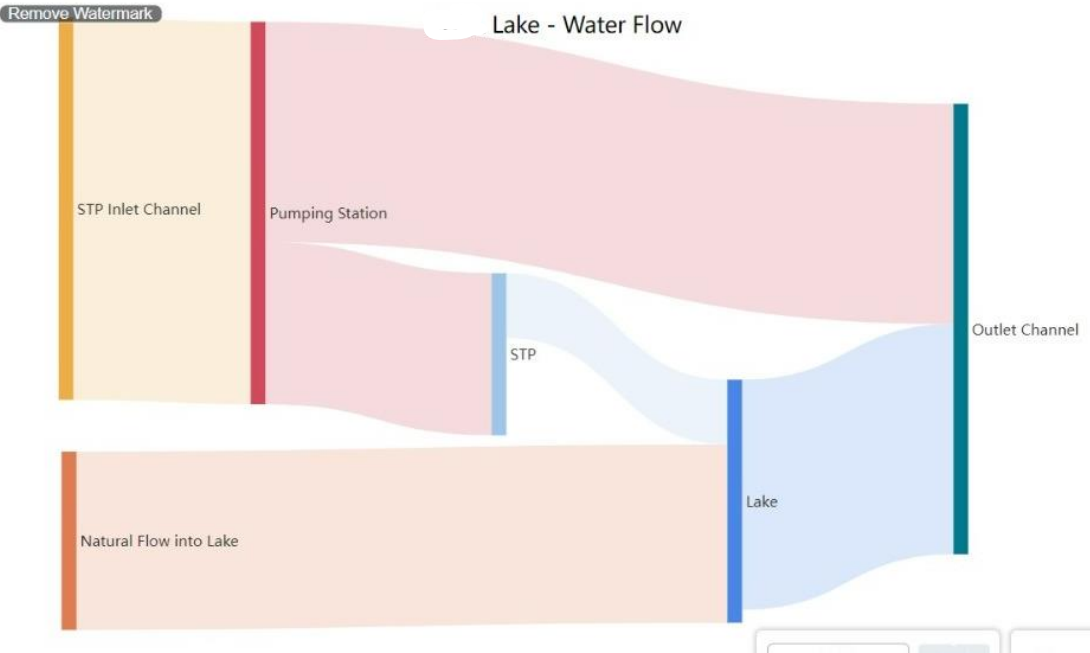
Figure 12: Flow of water/wastewater in and out of IDL Lake (Numbers in the image are represented by MLD in units)

The data from the flow measurements clearly indicates that the lake is at its full carrying capacity and the water balance is clearly seen (7.5 MLD of inflow and 7.1 MLD of outflow).

Treated water from the STP is let out into the lake. In delivering treated wastewater, a gap of 3 MLD was observed on the day of measurement from the STP, and this could be because of operational reasons (varying operational hours, under maintenance etc.). The Sankey diagram below shows flow of water/wastewater into the lake and its outflow.

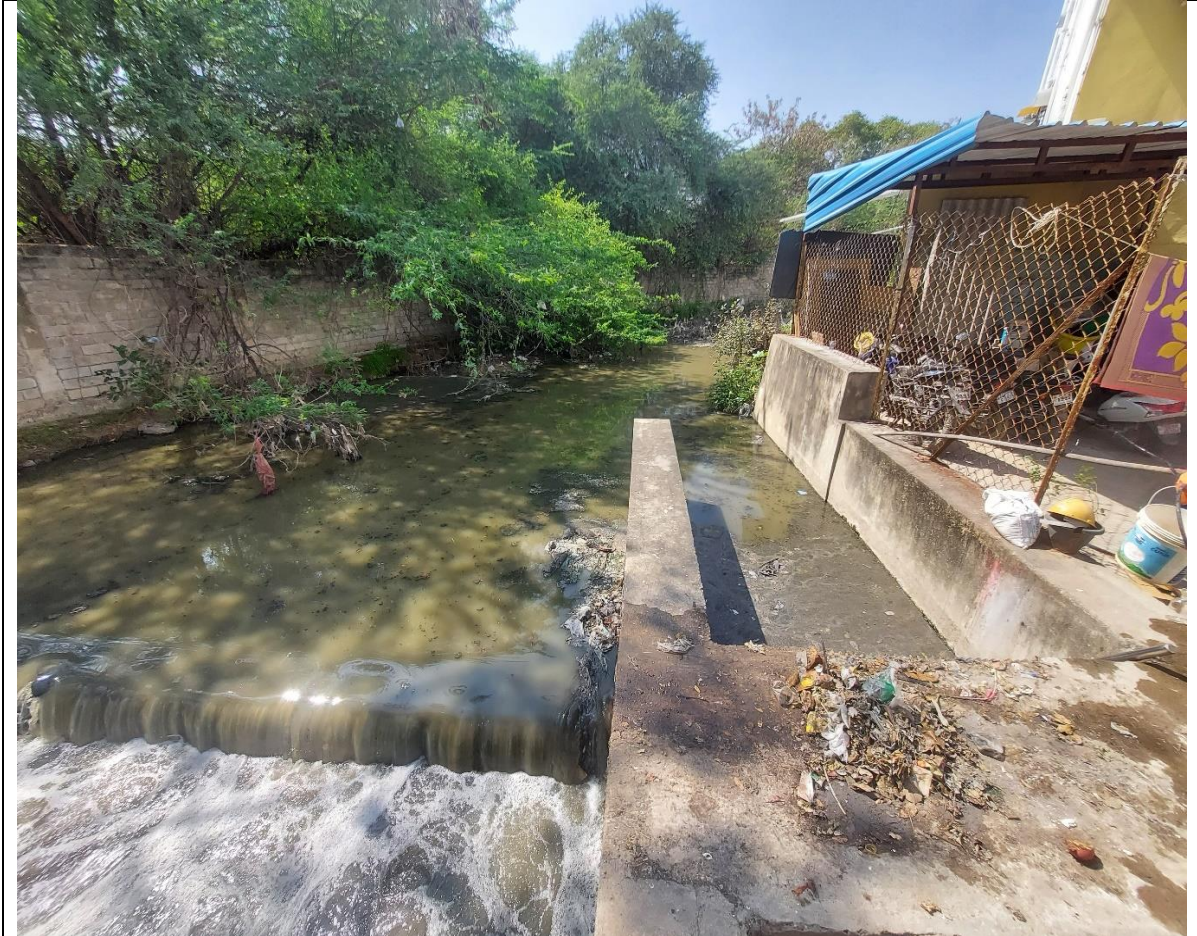
Figure 13: Water diversion structure at Balajinagar (Sample Point 2a and 2b) – The channel on the left carries water directly into the lake and the one on the right screens solid waste and conveys water to the pumping station

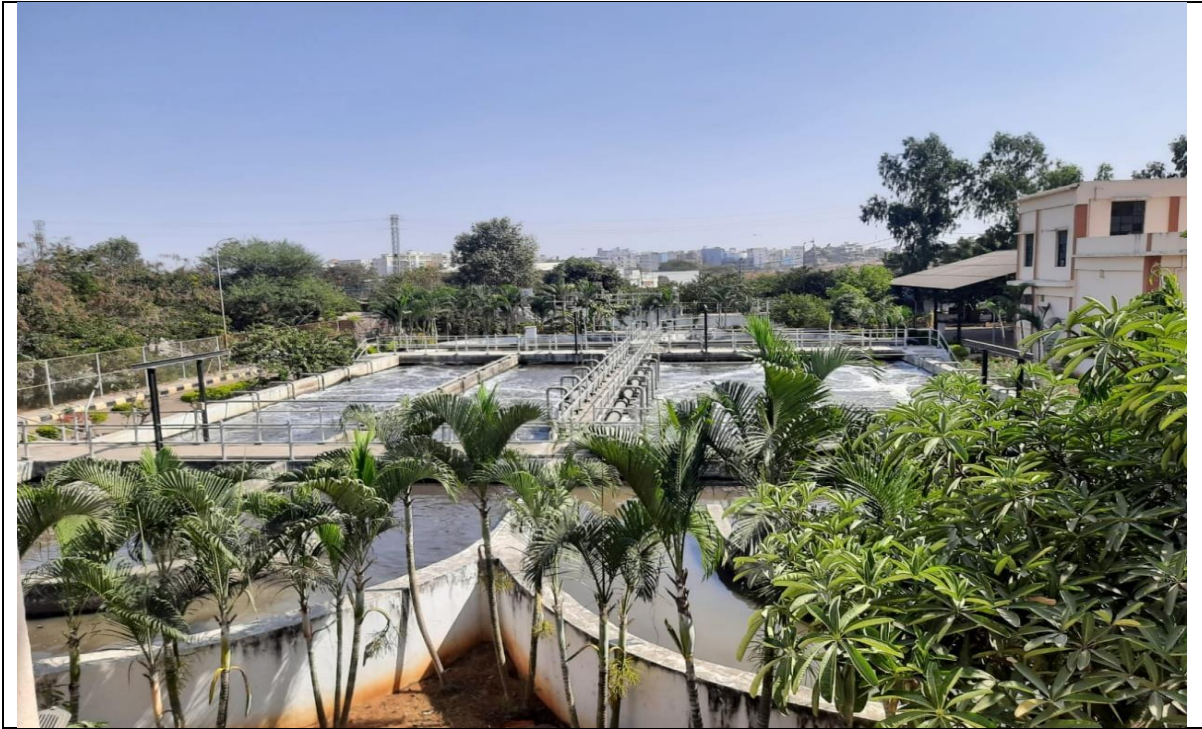
Figure 14: 5 MLD Sewage Treatment Plant (STP) established and operations along the bank of the lake

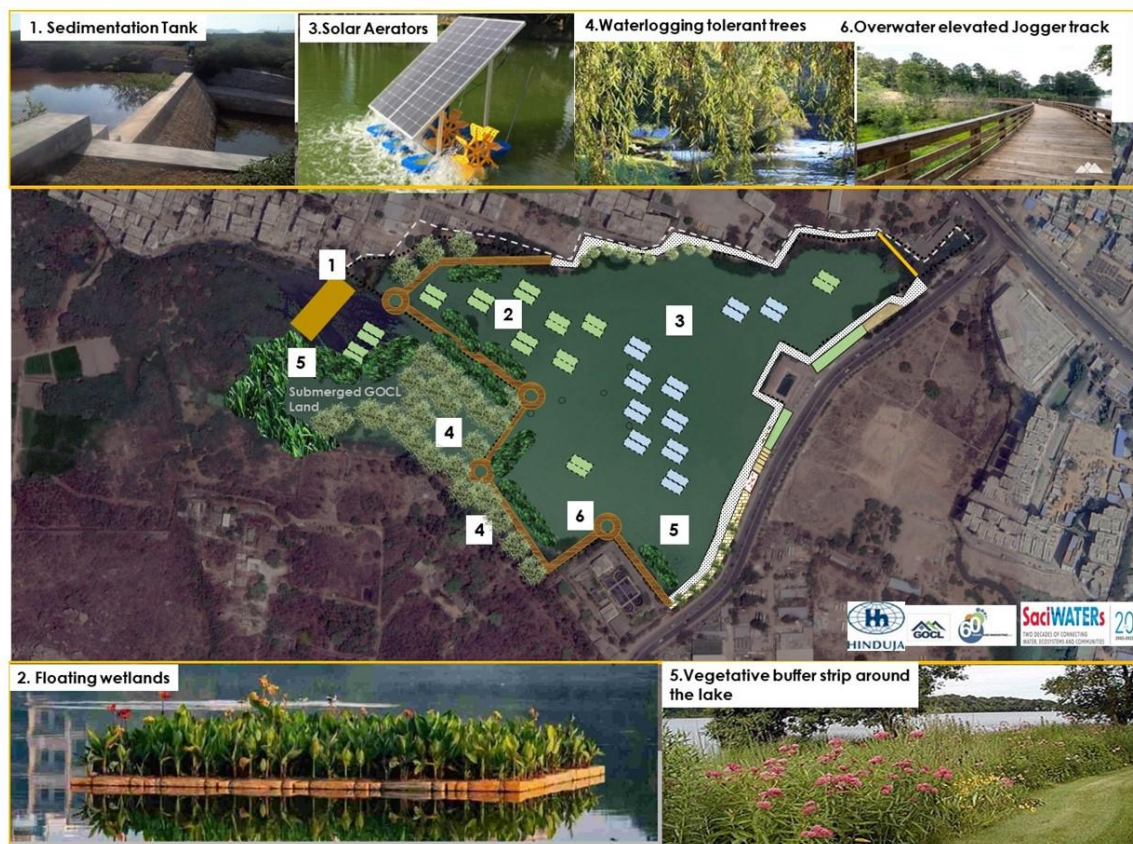
Figure: Visualization of all the potential interventions at the IDL lake

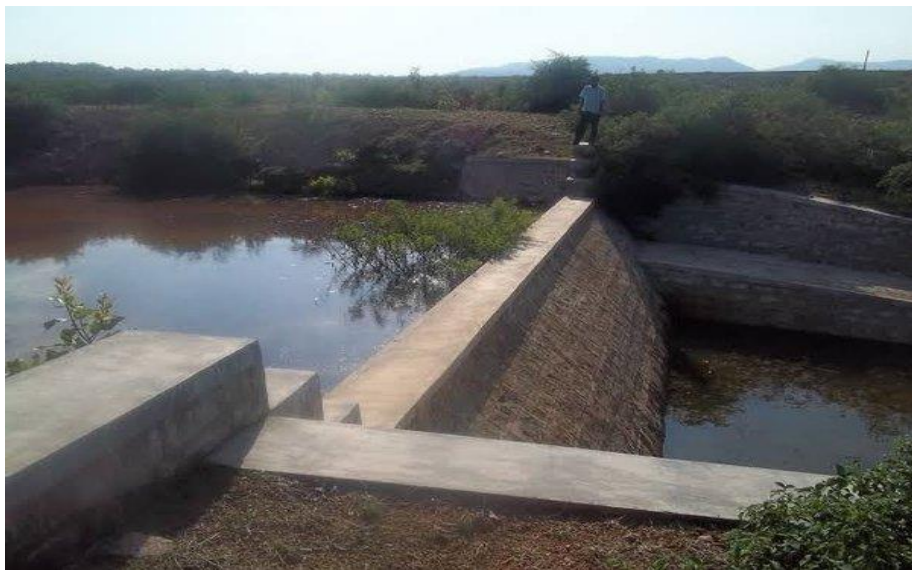
Sedimentation Tank at the mouth of the Lake (*reference image*)

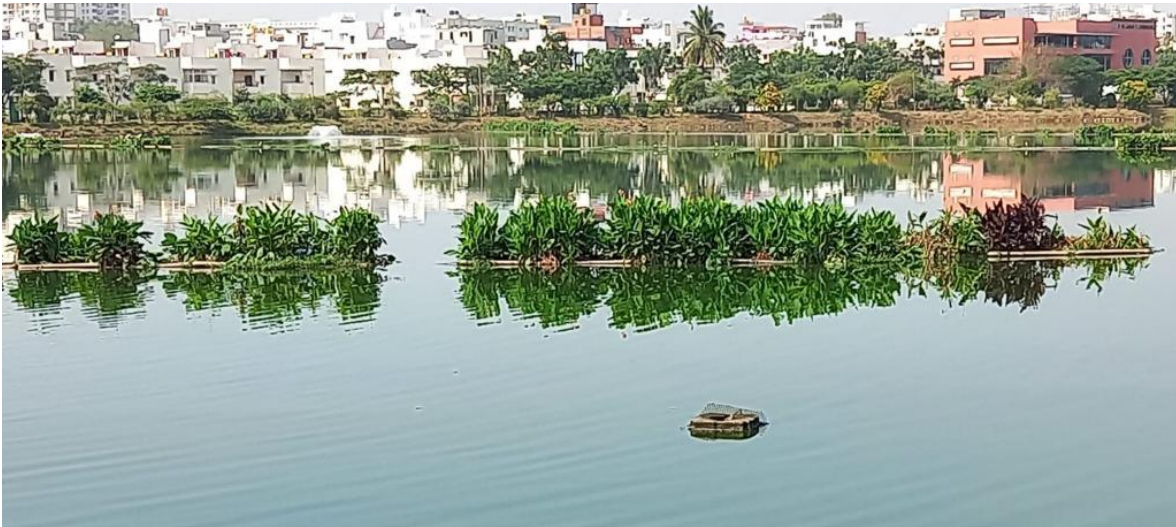
Floating wetlands (Reference image)

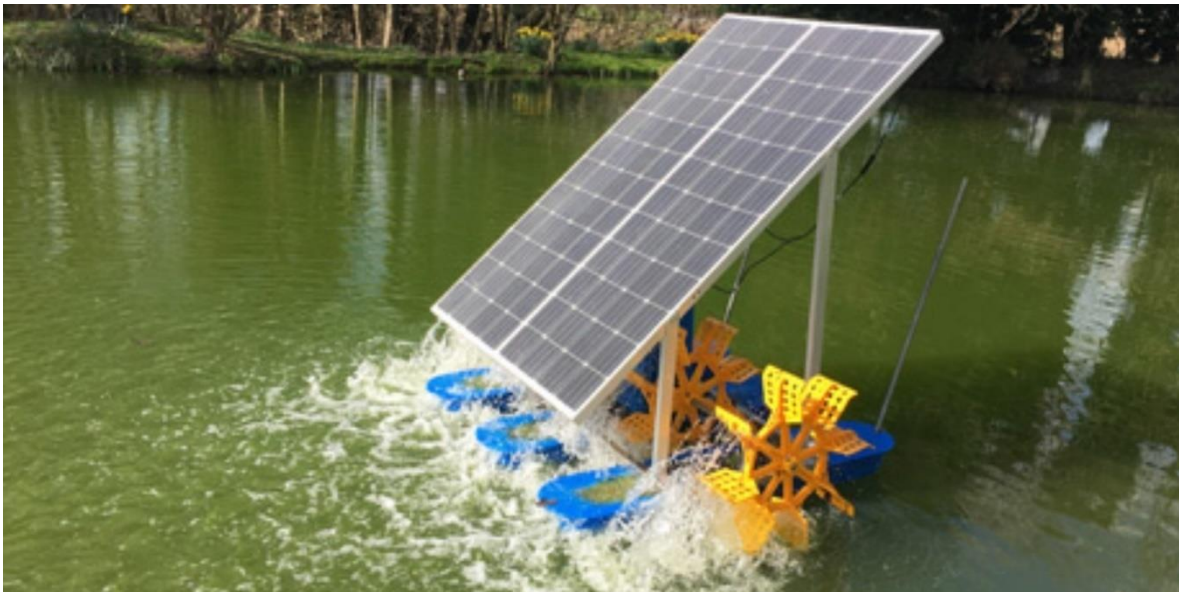
Solar Aerator (Reference image)
