# Lake Study in the Peri-Urban extent of Hyderabad

## Baseline Assessment of physical condition and stakeholder mapping

5<sup>th</sup> March 2022

**Avinash Kumar;**  
Technical Consultant  
Urban & Regional Planning Advisory Services

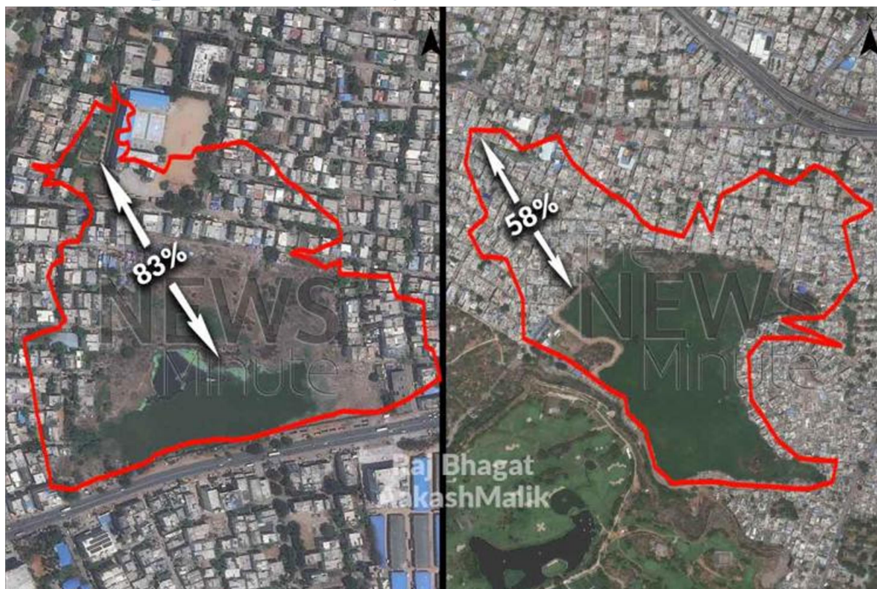
Figure 1: The above image is an illustration developed at the World Resources Institute showing the Ramanthapur Cheruvu<sup>1</sup> on the left and Gurram Cheruvu<sup>2</sup> on the right (Goode, 2021)

The above image provides an account of physical change taking place temporally for two lakes in the city of Hyderabad. While this is only a specific case of two lakes, such is the situation prevailing across most inland water bodies in the city of Hyderabad.

<sup>1</sup> The Ramanthapur Cheruvu on the left shrunk by over 83% — from 1.2 lakh sq m to a measly 20,000 sq m.

<sup>2</sup> The Gurram Cheruvu lake on the right shrunk by almost 55% — from 3.3 lakh sq m to 1.5 lakh sq m in this period.

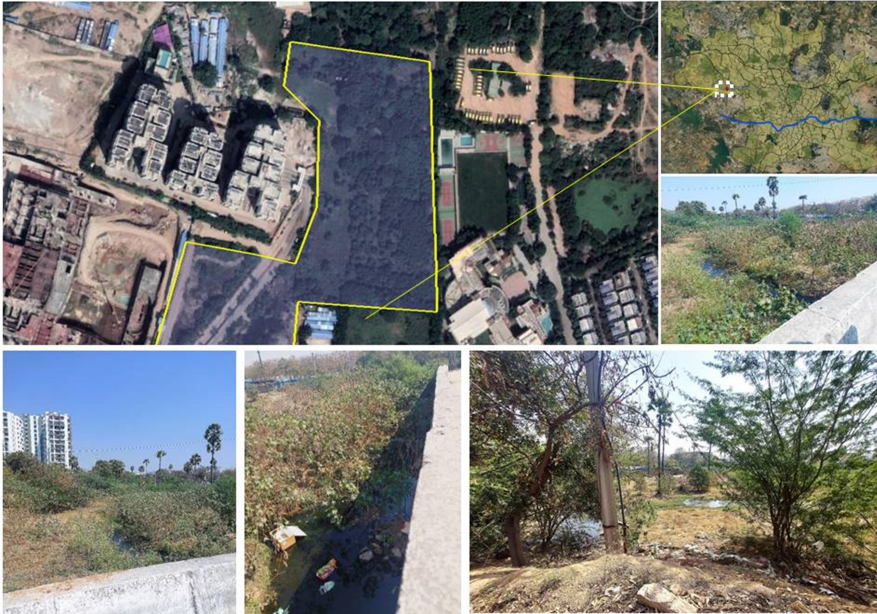
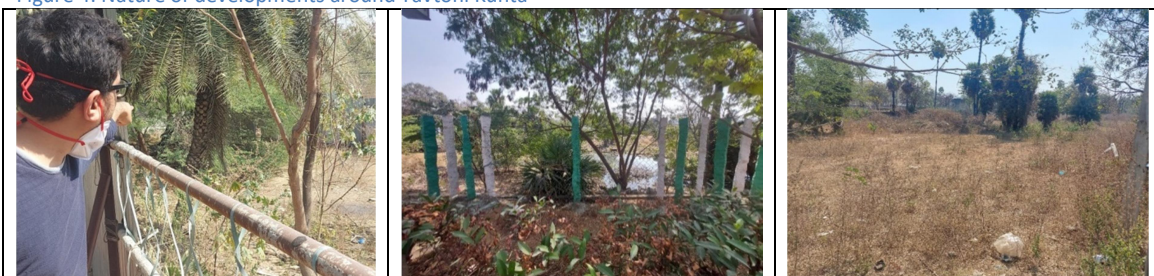
Figure 3: Different views of Tavtoni Kunta

Figure 4: Nature of developments around Tavtoni Kunta

Figure 5: Illustrations captured around Tavtoni Lake

Tavtoni lake is currently dry and is surrounded by existing and upcoming developments. The inlets of the lakes are not visible but a small sewer drain passes through the lake-bed and pools near the outlet. An access road to a nearby residential cuts the lake bed into two areas. The lake drains into Khajaguda Lake just across the road that acts as bund of the lake.

S.No.	Name of Lake	Baseline Situation	Land use Ownership
1.	Tavtoni Kunta	The overall situation of this lake is a situation of the watershed drying up. At the watershed level, the drainage of water should be allowed to flow unrestricted in order for the lake to first have water.	Large private residential gated communities and a few institutions and commercial establishments.
2.	Wipro Lake	This lake is owned and gated by the company WIPRO. The situation seems to demand only beautification following which the lake can be connected to the passerby or people within the	One main arterial road and an institutional campus covering one side of water body.

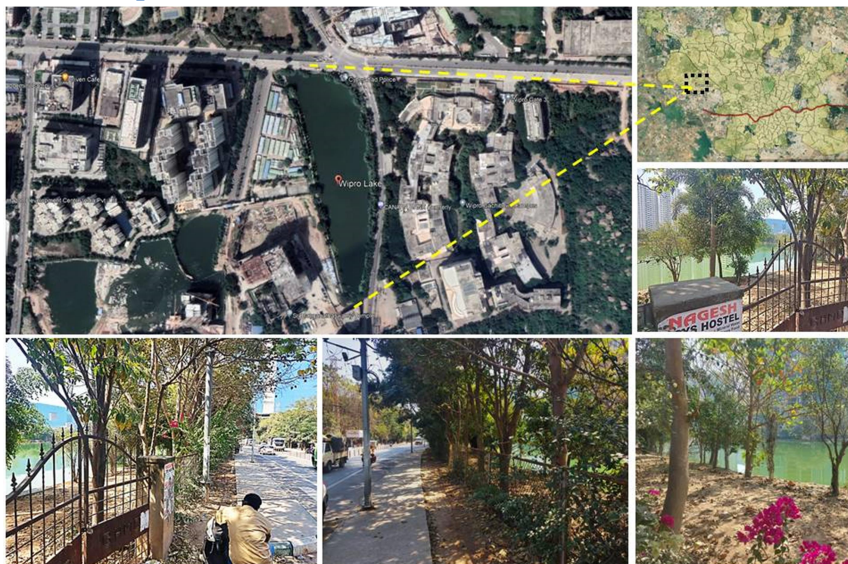
Figure 6: Different views of Wipro Lake

Figure 7: Nature of developments around Wipro Lake

**Wipro lake** is currently filled and is in between the financial district of the city with mix of both residential and commercial activities along the edges of the lake. The lake has a walking lane, and it is gated and with minimal visible pollution.

Figure 8: Illustrations captured around Wipro Lake

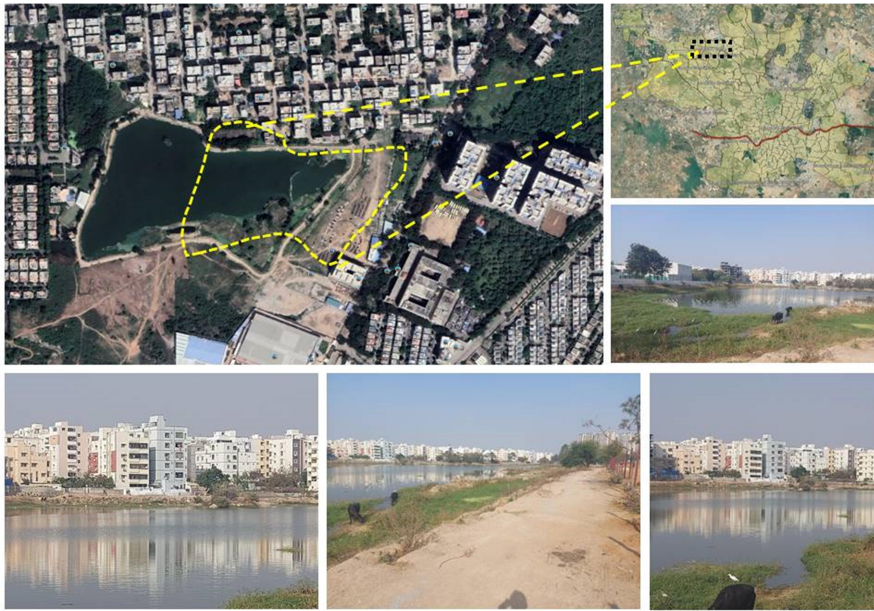
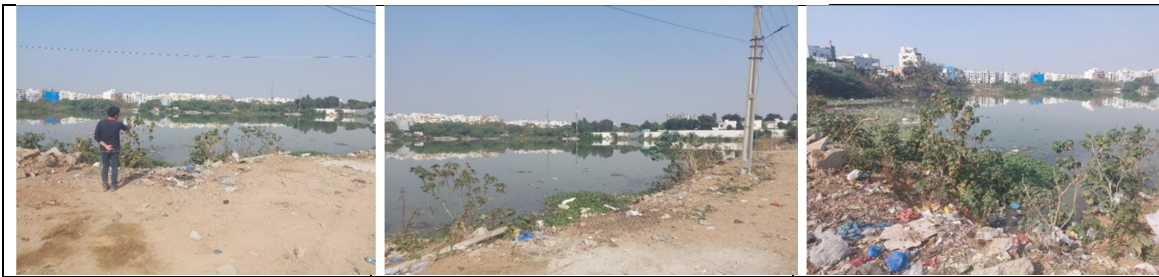
Figure 9: Different views of Meedi Kunta Lake

Figure 10: Nature of developments around Meedi Kunta Lake

Figure 11: Illustrations captured around Meedi Kunta Lake

Medium sized lake linked to Khaidamma kunta lake with a gated community on two sides of the lake. Medium dense residential community to one end and vacant land under transition on the other. The lake has been cleaned and maintained well. Source of this effort is unknown. Though the lake is in a good condition, accessing the lake is tough due to lack of process access to the lake.

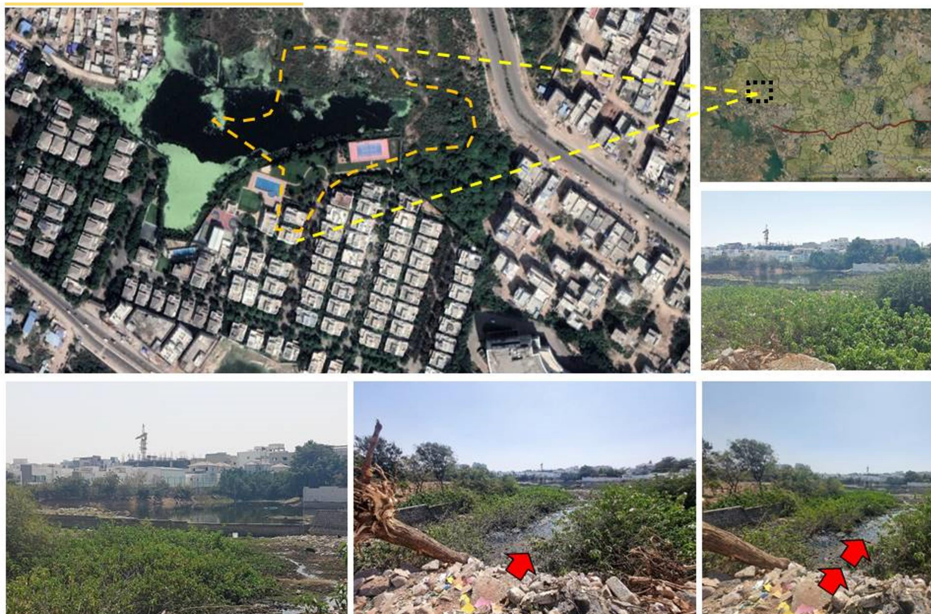
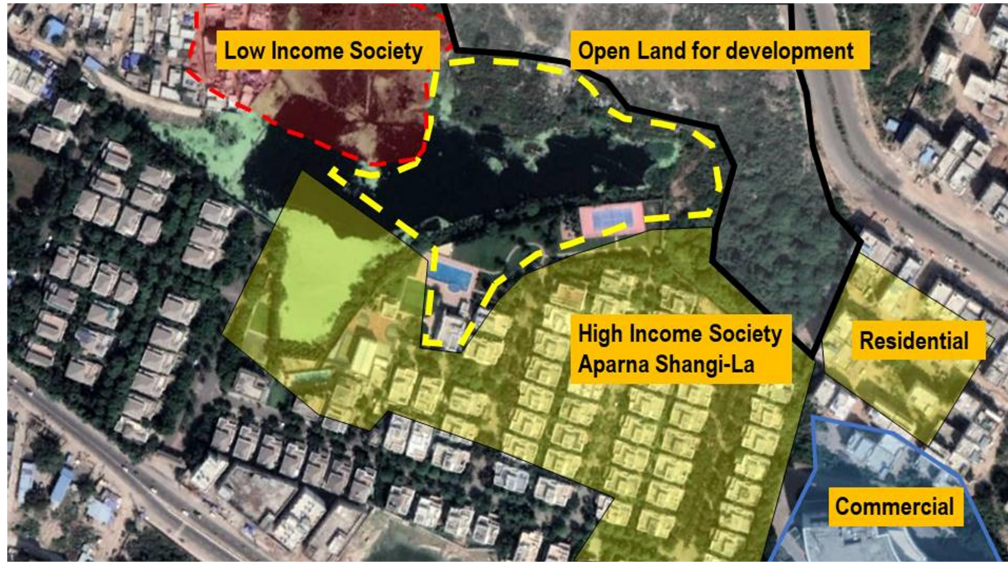
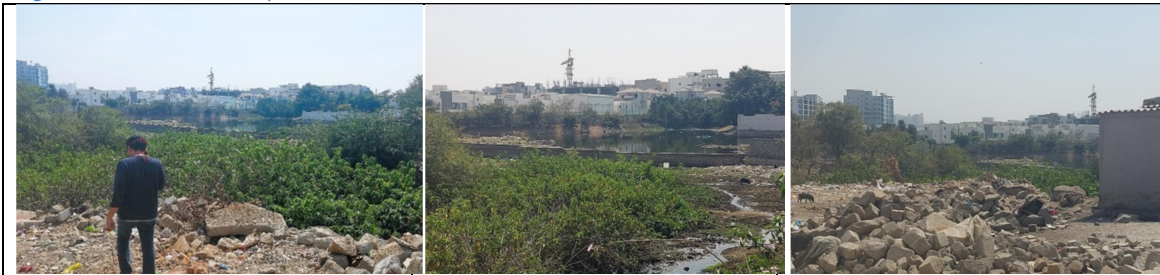
Figure 12: Different views of Gosai Kunta Lake

Figure 13: Nature of developments around Gosai Kunta Lake

Figure 14: Illustrations captured around Gosai Kunta Lake

Gosai Lake has been just adjacent to Aparna Shagri-LA society with no proper access. The only way to access the lake is from low income community behind the Sri Sai Housing colony. Untreated sewage has been identified entering the lake from the community and heavy eutrophication has been spotted. Active bubbling and patches of oxidation have been spotted in the lake. The shoreline is complexly filled with construction waste barring any access to the lake.

WIPRO campus.	
3.	<b>Gosai Kunta</b>	North East of this Lake is covered by low income settlements which need community level intervention and south of the lake, Aparna Constructions (Shangrilla) needs regulation in the form of Zero Discharge to avoid the lake from being deteriorate by effluents.	Few informal settlements on one side and one major gated residential community on one side of river.

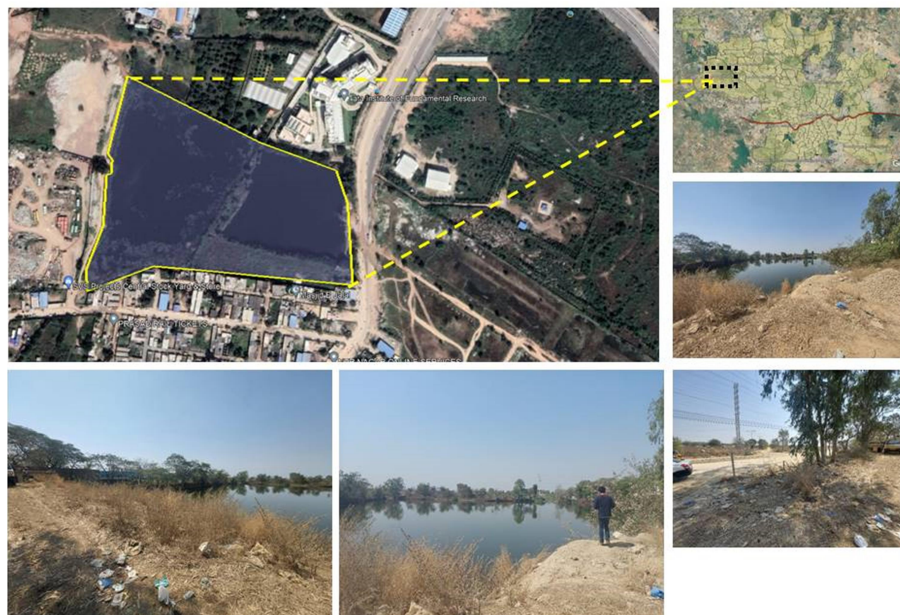
Figure 15: Different views of Komati Kunta Lake

Figure 16: Nature of developments around Komati Kunta Lake

Figure 17: Illustrations captured around Komati Kunta Lake

Komati Kunta is adjacent to Tata Institute of Fundamental Research and surrounded with commercial establishments. No visible pollution is seen near the lake. Developments around the lake are yet to come up. On the other side of the lake is HCU campus which acts as buffer to the lake. Land behind the lake is predominantly agriculture and plotting for developments has been identified.

4.	<b>Komati Kunta</b>	South of the lake has commercial developments (Looks like one lake; but needs to be clarified) which needs regulation to prevent the aquifer loss feeding the lake	Few institutional entities and commercial establishments around the lake with a road on one side.

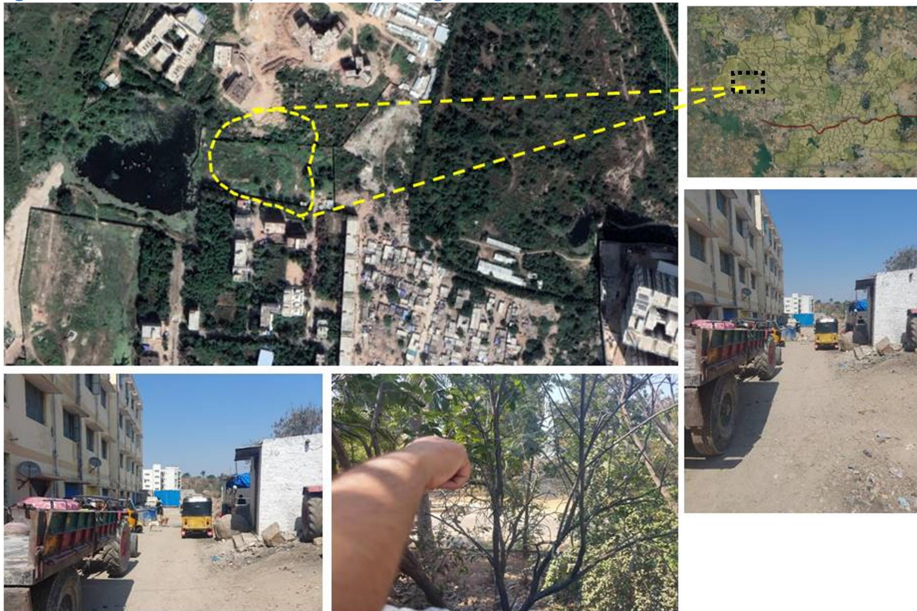
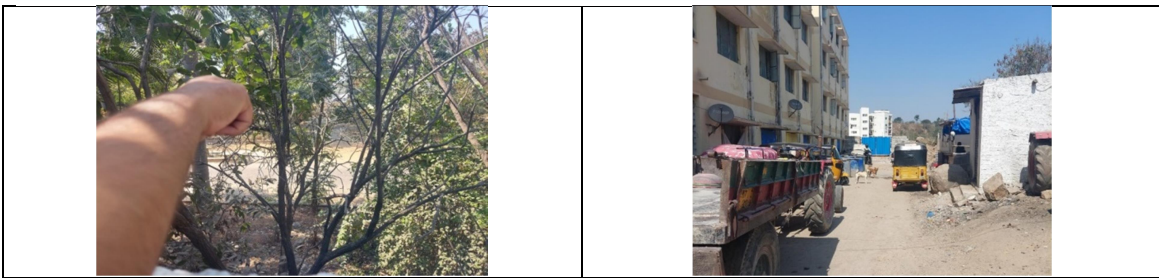
Figure 18: Nature of developments around Edlagavani Kunta Lake

Figure 19: Different views of Edlagavani Kunta Lake  
Table 6: Edlagavani Kunta Lake Profile

Figure 20: Illustrations captured around Edlagavani Kunta Lake

The Kunta is completely surrounded and has no access we could find. Large construction activity has blocked the access. So not much observations could be deducted from the current lake.

5.	<b>Edlagavani Kunta</b>	Lake was not seen because it is occupied by Jaiberry real estate group. Needs to be informed to GHMC that adopting such a lake for any intervention requires the lake to be first inspected. Presently the site seems privately occupied.	Gated Community and School cover most of the lake boundary. But the lake boundary needs to be clarified as a path did not lead to the site. Was blocked from the outside.

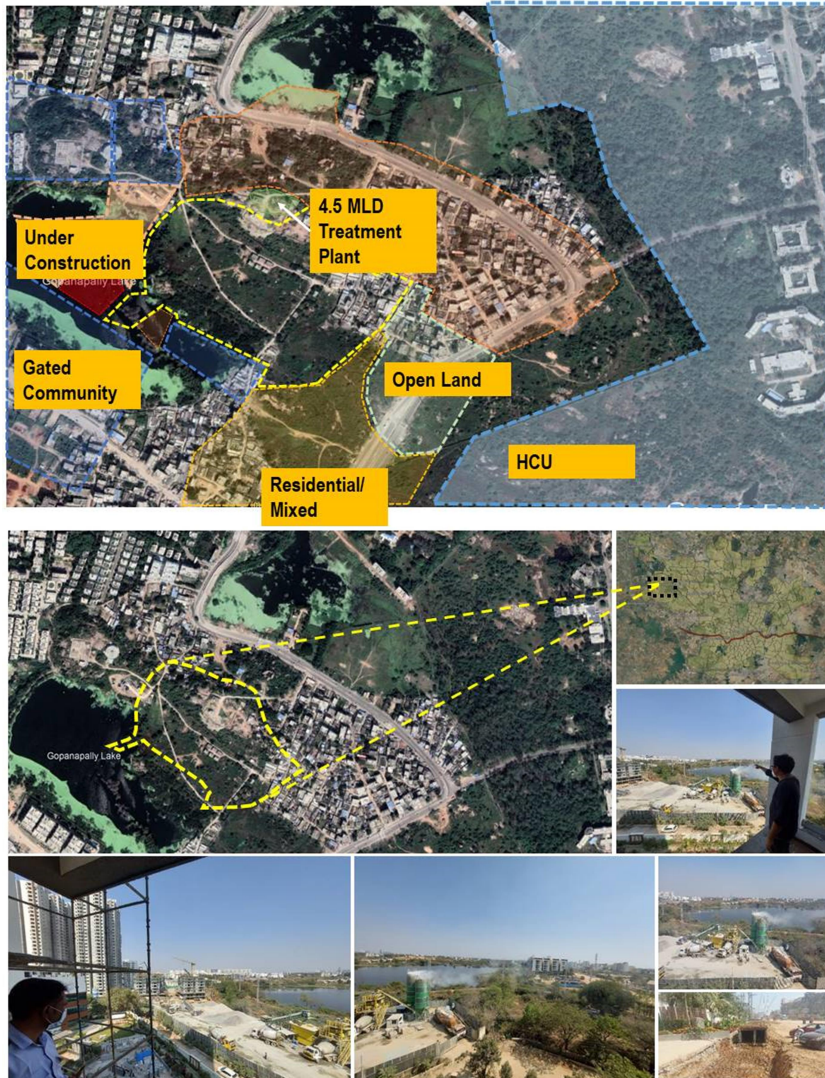
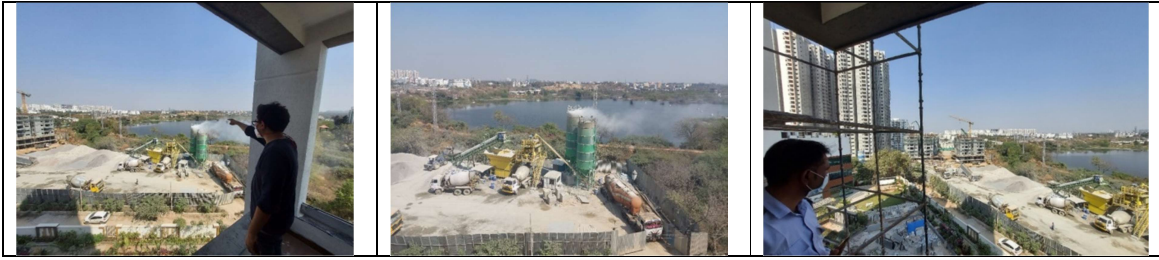
## 5.7 Chinna Pedda Lake – also called Goppapanally Lake

Lake is in process of degradation, being surrounded by gated communities. This is a massive lake and has a mixed land use dominated by residential use. The lake is close to HCU camps which allows sharing the ecological spaces of the same and is close to Komati Kunta. Lakes in HCU and Komati Kunta and the current lake can be developed into interconnected wetlands (if the geography is feasible) .

6.	<b>Chinna Pedda Lake/ Goppanpally Lake</b>	Land Use around the lake is not clear. A sewage treatment plant already is present but the inlet channels and land use must be ascertained.	Lake already has an STP which is seemingly defunct. Most of the lake boundary is covered by rampant constructions underway to build gated communities. Mostly gated communities flank the lake.

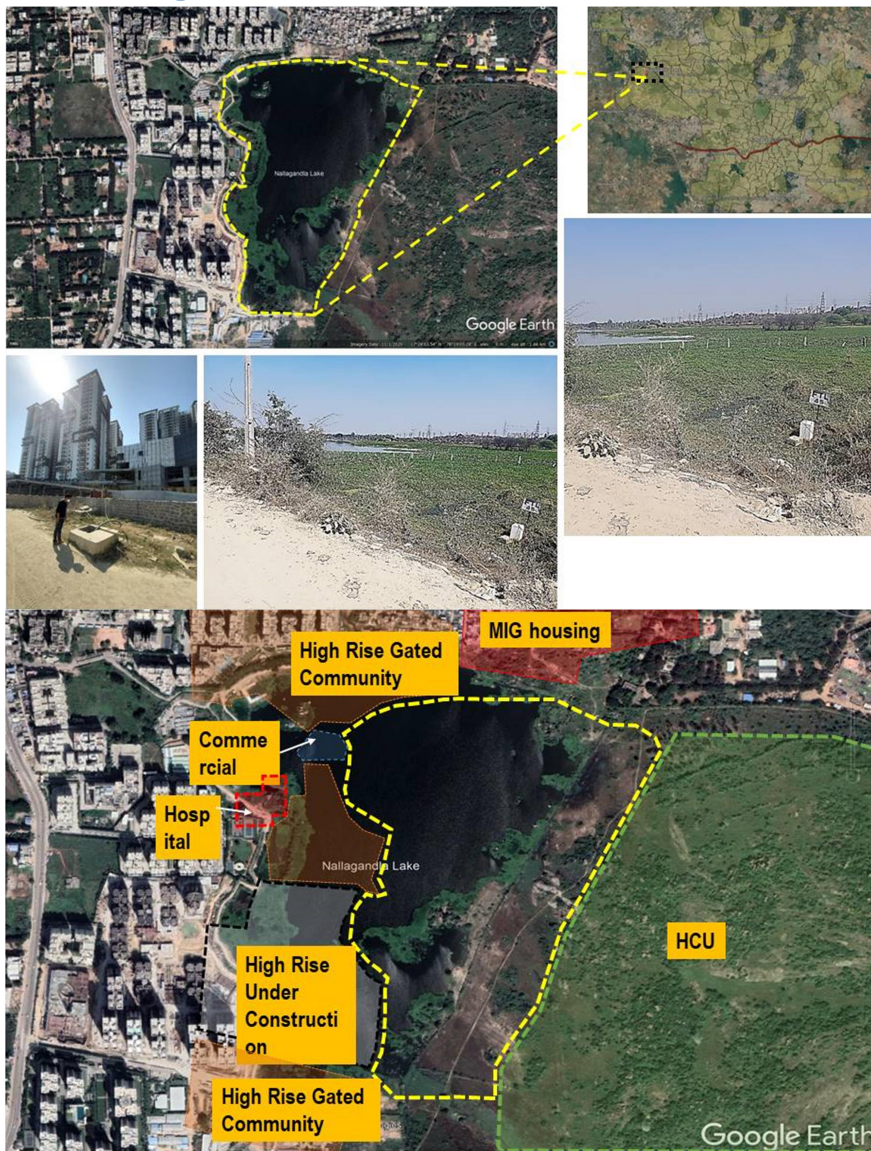
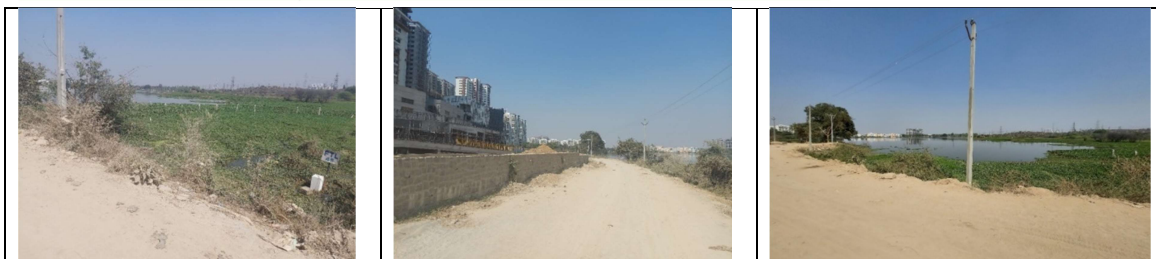
### 5.8 Nallagandla Lake

Second biggest lake from the list, The lake bed is filled with high rise residential projects, The building are so tall that they hit the aquifer for their foundations and are currently draining the water into the lake. The lake is in a fast degradation state with edges covered with hyacinth. A very important resource and can be taken up for rejuvenation may be once we have implement one example. This lake also is very close to other lakes (Gopanpally, Komati, Lakes in HCU, Gopi Lake) forming a interconnected wetland zone.

7.	<b>Nallagandla Lake</b>	To the west side (occupied by Aparna Constructions), there is water that is being pumped out which will affect the lake. But the land use is stable all around so an intervention seems feasible.	This lake is again flanked by gated communities. There is one by aparna constructions which is pumping water out of the lake as noticed at site.

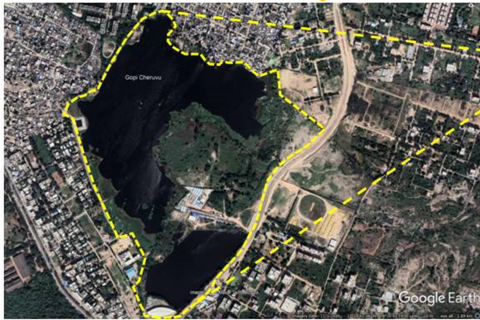
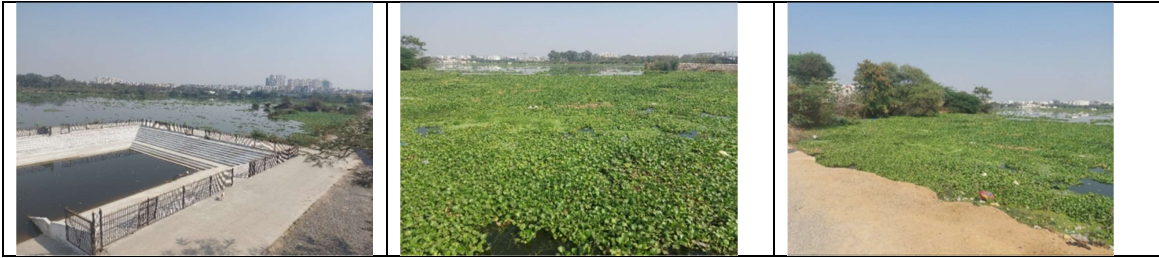
## 5.9 Gopi Lake

The biggest lake from the list, The lake bed is surrounded with Middle income and low income housing built. The lake is accessible from two sides. One of the main access to the lake is Road no 9 of Serlingamaply Zone and land adjacent to the road is under the transition process from vacant lands to built up spaces. Landuse towards the bund has high dense characters and all the sewage is draining into the lake. A very large lake with complex landuse slowly heading towards degradation.

8.	<b>Gopi Lake</b>	Nature of Housing around makes community engagement with multiple RWAs a hurdle which is too difficult to address.	Flanked by too many small residential entities which brings in the challenge of negotiating participation from too many individual residential stakeholders.

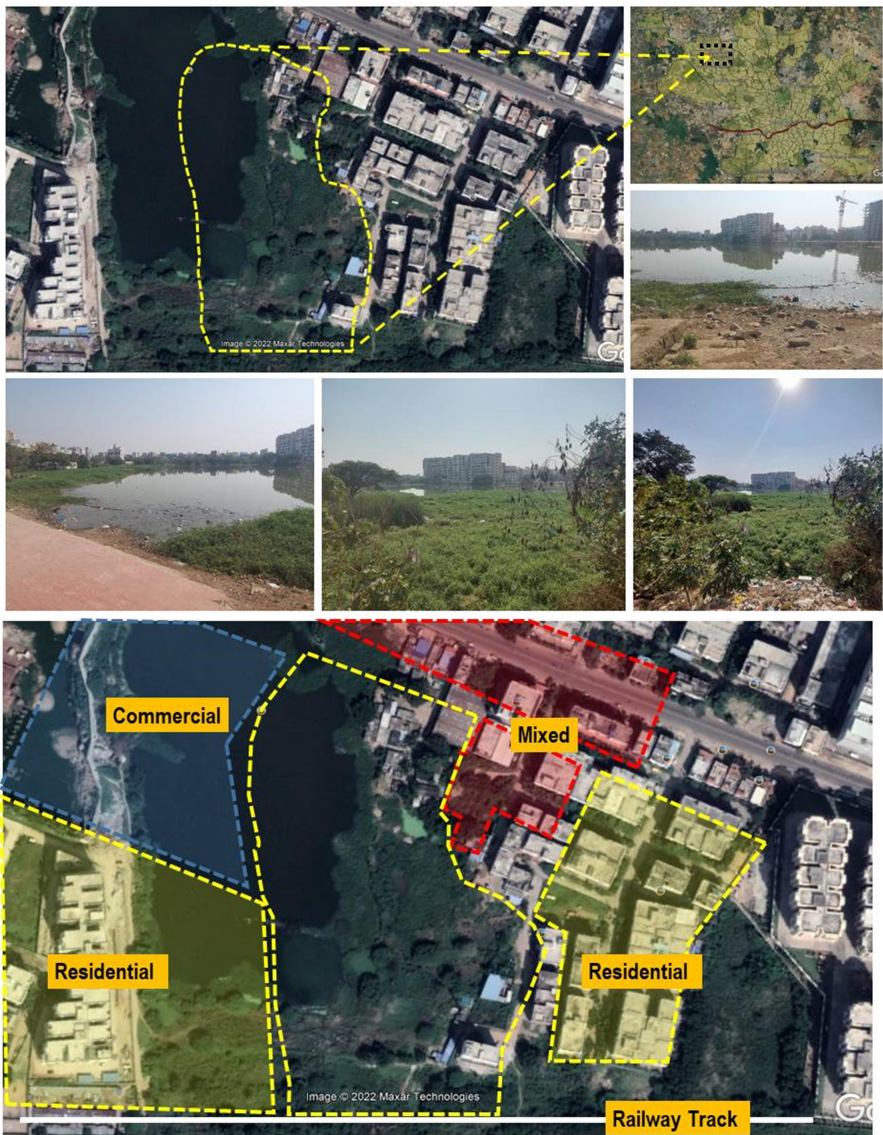
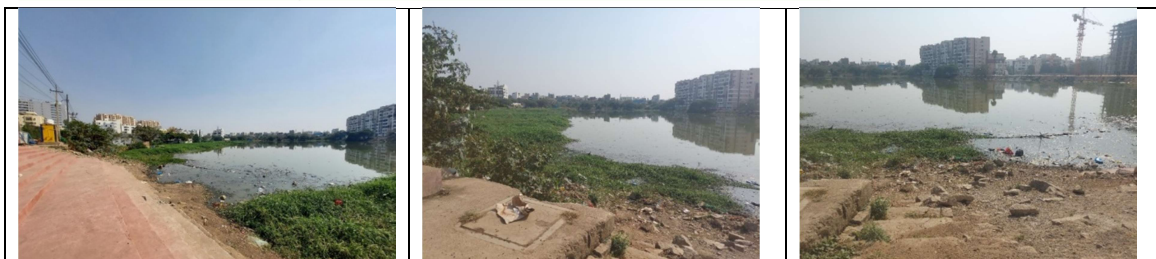
### 5.10 Patel Cheruvu

Patel Cheruvu is a small lake along the road. The lake is surrounded by residential buildings and new construction and in the back the lake ends at a elevated railway track. High eutrophication is observed in the lake and the shore line is fast eroding with development around the lake.

9.	<b>Patel Cheruvu</b>	Visually speaking the lake is located adjacent to a main arterial road; Place making may be required so as to make the residential settlements identify with the lake through community level social infrastructure.	This lake is flanked by a main road on one side and two gated communities on the other. Seemingly requires long term ownership from those communities, which makes the lake a favourable case for rejuvenation.

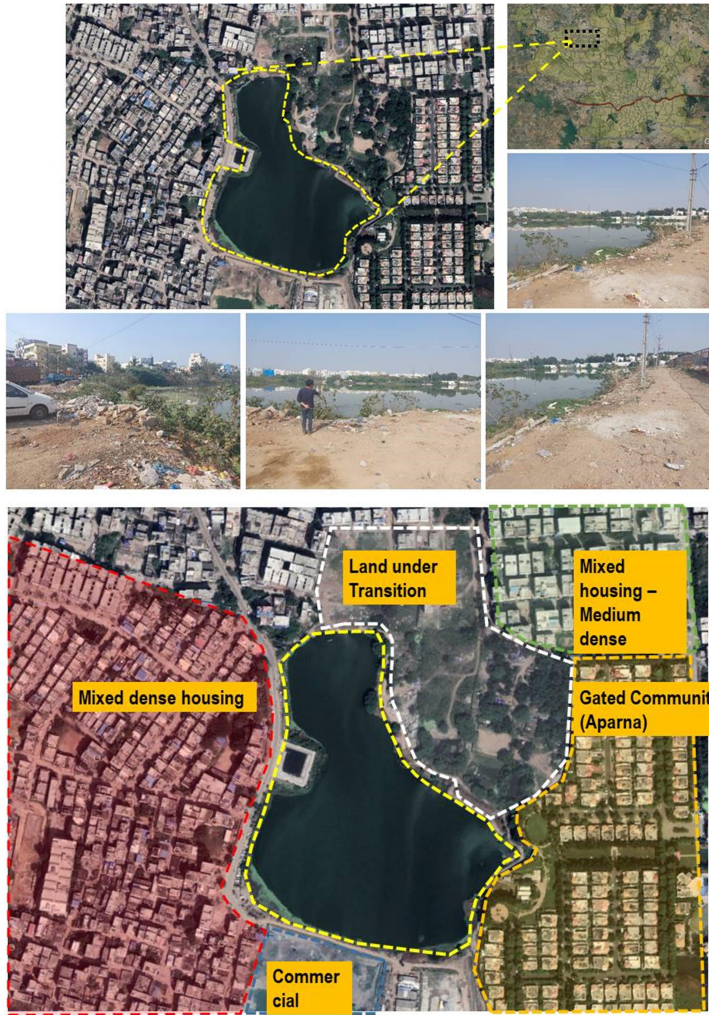
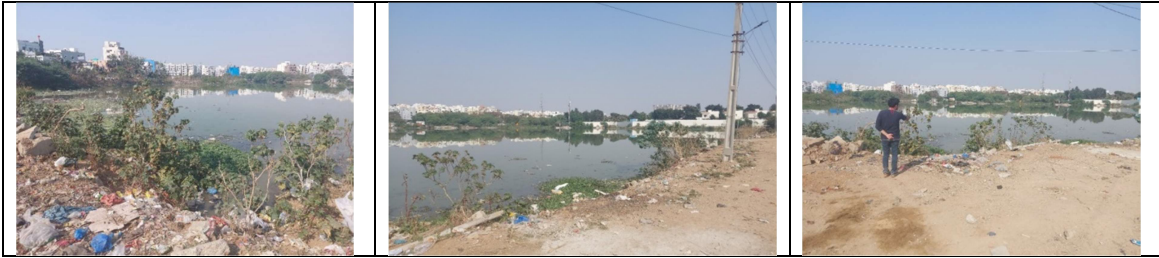
## 5.11 Kaidhamma Kunta

Medium sized lake linked to Meedi Kunta Lake with a gated community separating the both. The lake is surrounded with gated community, mixed dense housing and shorelines acts as a main access to the high dense housing areas. The gated community is acts as one of the banks of the lake and the water is seen to be heavily polluted with active bubbling and sewage inlet flowing directly into the lake. Heavy solid waste dumping along the shoreline has been observed.

10.	<b>Kaidhamma Kunta</b>	Huge mixed residential housing adjacent to lake and will be difficult to build a community engagement strategy for lake rejuvenation	Flanked by mixed individual residential entities all over with a few commercial establishments.

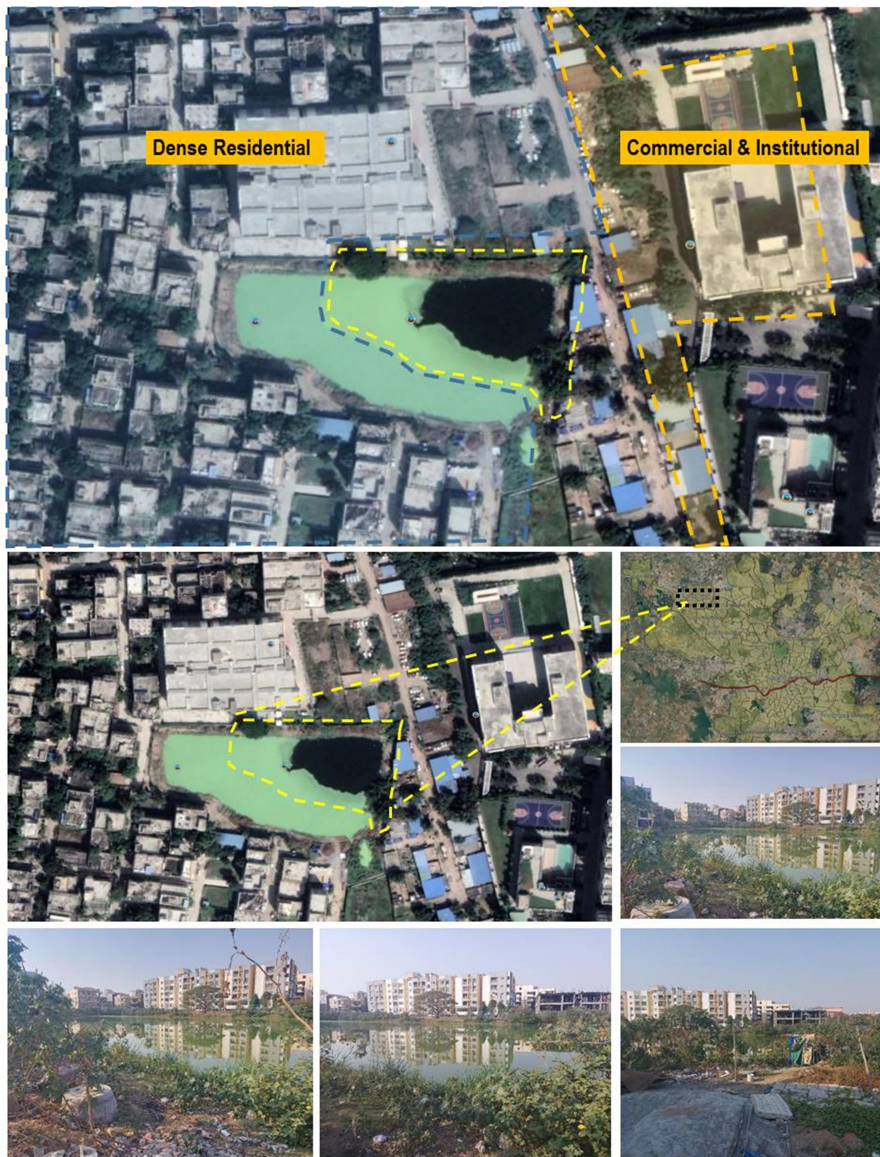
### 5.13 Bachu Kunta

Small water body in between dense housing connected with sewer lin. The water is green in colour and the residents mentioned – recently there has been clearance of hyacinth by the Government. A diversion canal has been made adjacent to the water body that acts as an outlet.

12.	<b>Bachu Kunta</b>	Hard to reach and covered on all sides by dense residential land use	This is also surrounded by low density residential entities but also the lake is difficult to access.

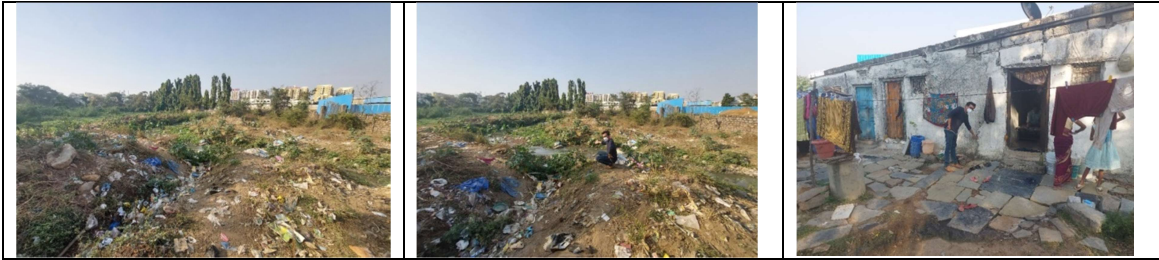
#### 5.14 Kalapuram Basti Cheruvu

HMDA marked the area as a lake, though the area is waterbody, it has been reduced to area with vegetation and the drain passing through the lakebed is the only water in it. The lake is completely dead. The lake swells during monsoons and floods the nearby houses.

13.	<b>Kalapuram Basti Cheruvu</b>	Because there is no water in the lake bed. This requires water shed level intervention and not a mere site specific treatment intervention.	This lake is surrounded by multiple low income settlement on one side and small commercial establishments on the other.
